Salt attack and rising damp

A guide to salt damp in historic and older buildings

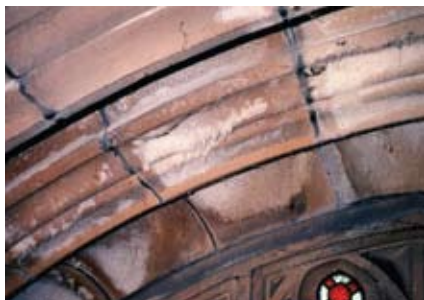
Figure 4 Thin needles of salt extruding from the top of a window arch. A slipped roofing slate punctured the copper roof gutter, allowing rainwater to wash salts into the stonework.

When the rate of evaporation from the wall surface is low (such as in humid climates, or in cellars and basements with little air movement) the evaporative front may be at or very near the surface, in which case salt crystals will grow as long thin needles, extruding from the wall face (Figure 4). This is known as efflorescence and is commonly seen as a relatively harmless white powder on the surface of new brickwork.

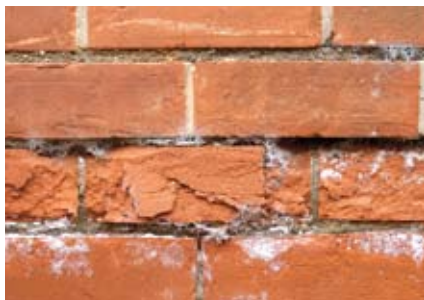
Figure 5 Salt attack in bricks causing disruption and loss of the fireskin, the harder outer surface that develops during firing in the brick kiln.

However, when the rate of evaporation is much greater, the evaporative front will be inside the wall and salts will crystallise within the pores of the masonry (subflorescence). The force exerted by rapidly crystallising salts is very high and sufficient to disrupt even the strongest masonry material. Crystal growth leads to either grain-by-grain loosening, which produces fretting and crumbling of the surface (particularly to soft mortars) or to delamination of a complete skin, such as the case hardening found on many sandstones (Figure 3) or the fireskin on bricks (Figure 5).

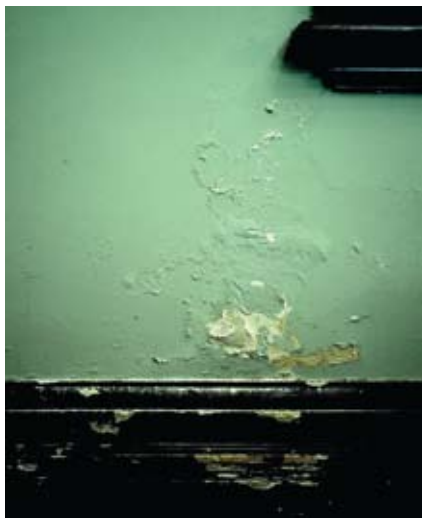
Figure 7 Typical blistering of paintwork and damage to internal plaster due to the combined effects of rising damp and salt attack. The skirting is a cement moulding and also shows salt damage.

Rising damp may show as a high-tide like stain on wallpaper and other interior finishes, and when more severe, as blistering of paint and loss of plaster (Figure 7, and also Figure 15). Musty smells are common in poorly ventilated rooms and particularly in cellars and basements (see Box 1: *Damp rooms may be unhealthy*). Externally, a damp zone may be evident at the base of walls with associated fretting and crumbling of the masonry (Front cover & Figure 2).

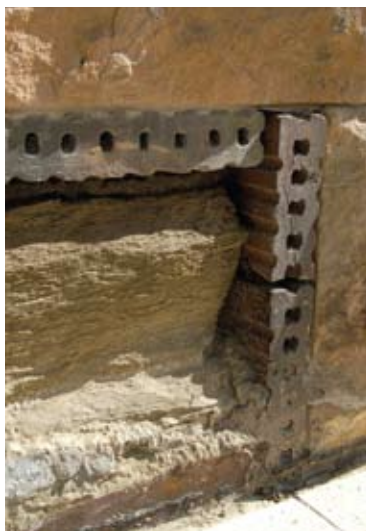
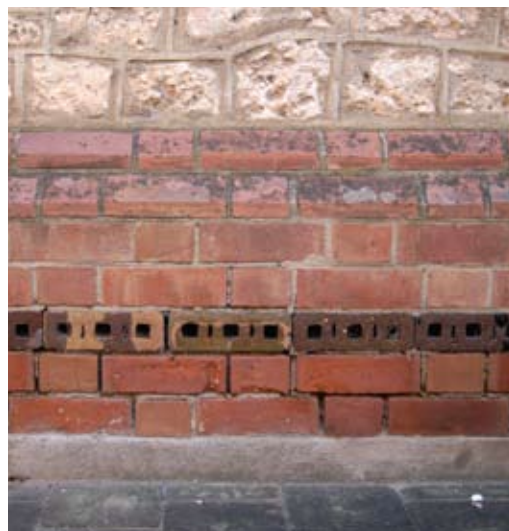
Figures 9 and 10 Hard burnt and glazed ventilating ceramic tiles and bricks. Made for the purpose, these are among the best dampcourses ever used, particularly the example at left from 1879. At right is a 1930s example which (together with its adjacent brickwork) is a remedial undersetting of an 1840s church of rubble limestone. Both examples were laid with open perpendicular joints to prevent damp travelling through the permeable mortar. In both cases salt attack is damaging the masonry below the DPCs — and each building will need treatments to control the salts (see Sections 13 & 14).

Some of the most effective DPCs used were glazed hard-burnt ceramic tiles or bricks, often with perforations allowing ventilation (Figures 9 & 10). These DPCs were laid without mortar in the perpendicular joints to prevent moisture passage through permeable mortar. The open joints also allowed through-wall ventilation. It is a great pity that glazed brick units suitable for DPCs are not made today as they have many advantages.

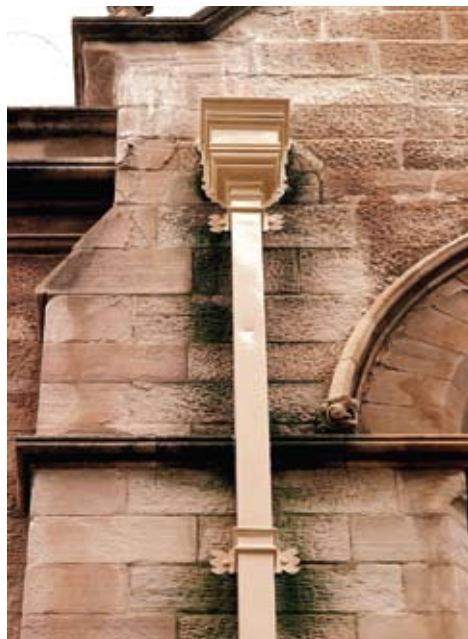
Figure 14 (right) Two examples of falling damp. Overflow from the blocked rainwater head is made apparent by dark green algae. The coping above the rainwater head is allowing water through to the stones below. Salt attack is causing these stones, above and to the left of the rainwater head, to decay.

The typical debris that builds up in roof gutters and on parapets (such as fallen leaves, bird manure, mosses and dirt) contains weak acids which will contribute to masonry decay by slowly dissolving weaker components leading to progressively more porous and permeable materials. Salts also accumulate on the tops of buildings, not only near the coast, where sea spray is a major factor, but even in central Australia, where wind storms whip up salts from the dry salt lakes and where tiny particles of salt rain from the sky. Though the rates of accumulation of air-borne salt are relatively low, with time a building can absorb sufficient salt to cause damage, particularly when it is all concentrated at one point, such as the top of a blocked downpipe or rainwater head. The importance of regular maintenance of gutters and downpipes cannot be over-emphasised (Figure 14).

evaporates from the wall surface and leaves the salts behind (Figures 4 & 14). Tracing damp back to the point of entry can be difficult, particularly when the masonry is rendered and/or painted and the moisture is trapped behind the render or paint coating.

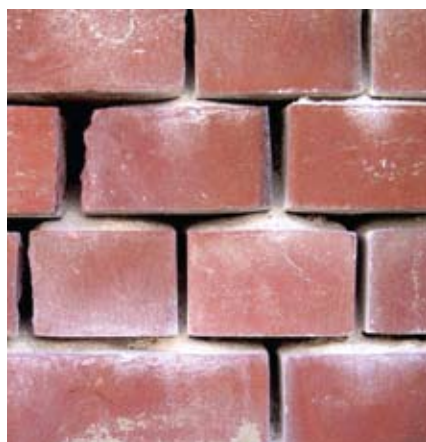
Figure 18 Extensive loss of lime mortar due to salt attack. The bricks remain sound — protected by the weaker mortar. Any further mortar loss risks local collapse of the brickwork. Successful repair may require dismantling and reconstruction as is done when undersetting (See Section 16.1).

There is a long period of almost no decay (in this case about 80 years) during which time salts are slowly accumulating within the masonry. Only then do they fill the pores sufficiently to cause significant salt attack decay. By the time the house turns 100 the decay has accelerated to near its maximum rate (the slope of the line), and in only ten more years the decay will be twice as bad as it is now. There are two important lessons from this. The first is that procrastination is not an option — something must be done, and done soon, or sufficient mortar will be lost to cause partial collapse of the walls (Figure 18).

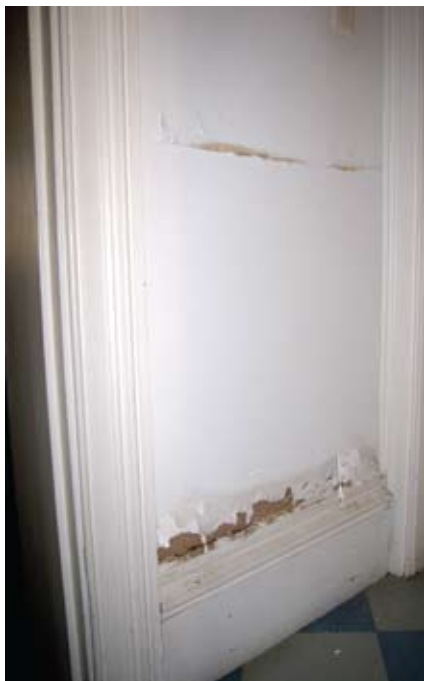
Figure 20 Evidence of previous treatment with hard impermeable plaster. Damp is evaporating from above and below the impermeable zone.

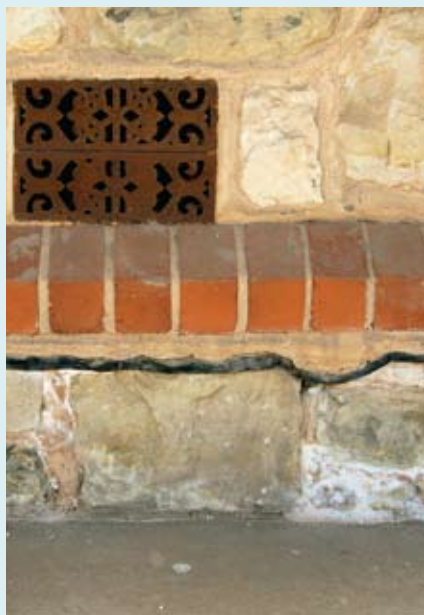
Contaminated materials

Beware of contaminated materials such as sands and other aggregates. Chemical analysis of the strong efflorescence in the photograph shows it to be predominantly magnesium sulphate (epsomite), a very soluble salt. Its origin is almost certainly from contaminated dolomite quarry sand used as a bed for the concrete paving in the foreground. A former quarry produced a dolomite aggregate for concrete and roadmaking and the crusher fines (quarry sand) were widely used as a bed for paving bricks and concrete. Some parts of the quarry contained pyrite (iron sulphide) which, on exposure to the atmosphere after crushing, oxidised to liberate sulphuric acid.

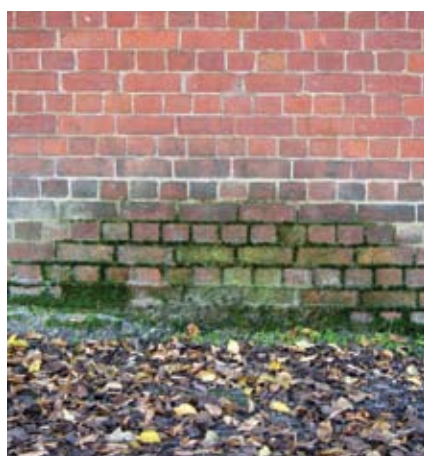
Figure 23 Maintenance, maintenance, maintenance. Here a roof gutter has rusted through and the colourful green damp zone is due to splash.

Maintenance is important. Too often damp problems are the result of neglect and bad housekeeping: circumstances that can be avoided. Regular maintenance of roof drainage systems, including gutters and downpipes, will involve cleaning gutters and rainwater heads, re-aligning gutters to ensure correct falls towards downpipes, and repairing leaks as soon as they are discovered. Ideally, roof drainage should be inspected during periods of heavy rain so that overflows and other failures can be identified (Figure 23). Are the stormwater systems adequate — are there enough downpipes and are gutters and downpipes of sufficient size?

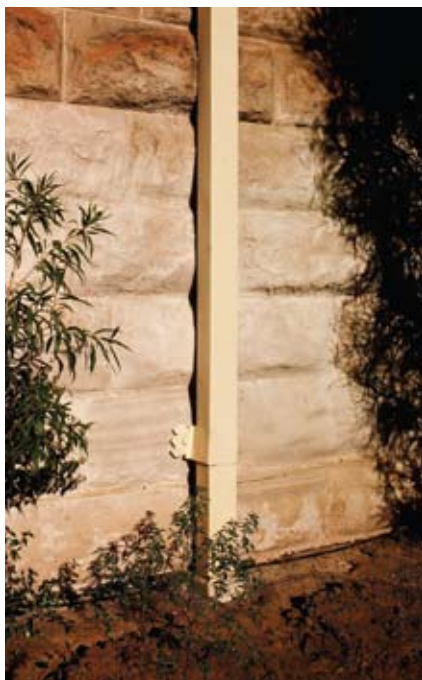
Figure 24 Garden beds against walls almost guarantee salt damp problems. Here the DPC was buried by 300 mm of soil — five courses of sandstone have been severely damaged.

Figure 25 Sterile zone between wall and garden — paved with coarse gravel to allow rainfall in and evaporation out. Drainage is provided by an agricultural drain wrapped in geofabric. Garden sprinklers are replaced with drippers and are kept at least 500 mm away from walls.

Gardens against walls are particularly bad — soil levels build up as mulches are added, fertilisers contribute soluble salts and watering by enthusiastic gardeners washes it all into the walls (Figure 24). Garden beds should be pulled back and a sterile zone at least 300 mm wide left against the walls. Sprinkler systems should be replaced with drippers and kept well away from walls (Figure 25).

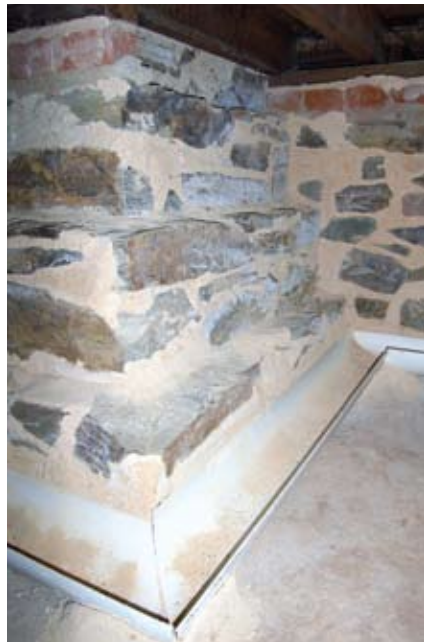
Figure 27 Semi-circular sections of PVC piping catch salt and other debris from sacrificial plasters and mortars on the walls beneath the floor of a church. Bedded on the same sacrificial mortar mix as that used for the walls, the pipes prevent the recirculation of the salts through the soils below and are cleaned out annually. White salts are visible on the stones in the centre of the photograph.

Controlling evaporation of moisture from sub-floor walls or from adjacent soils is one of the fundamentals of successfully managing rising damp. The emphasis is on control because there can be too much of a good thing. Too much underfloor ventilation may lead to salt attack on the inside faces of walls and on dwarf walls supporting floors. This could lead to unseen damage and could become dangerous. Regular inspection of underfloor spaces is therefore important. Where higher rates of ventilation are needed to manage dampness it may be necessary to apply sacrificial plasters to vulnerable walls (Section 13) and to catch debris from them so that salts are not recirculated (Figure 27).

As they crumble, sacrificial mortars and plasters will produce a dust of sand, lime and salt which should be collected and periodically removed, rather than allowing the salt to re-enter the soil and so be recycled up the wall. When protected from rain strike (internally, in a cellar, or on a veranda) a drop-sheet of strong plastic sheeting can be useful (Figure 31). An alternative treatment, using half round PVC piping beneath a timber floor is shown in Figure 27.

Surface deposits of salt (such as those shown in Figures 4, 5, 27, 30 & 50) should be removed using an industrial vacuum cleaner fitted with a brush head. Brushing alone will work, but the vacuum has the advantage of capturing the salt, preventing its recycling through the soils beneath.

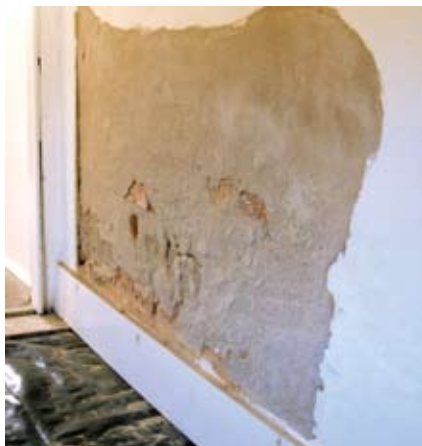
Figure 31 Sacrificial plaster decaying as intended. Plastic sheeting is used to catch the salts and prevent their recycling through the soils and walls.

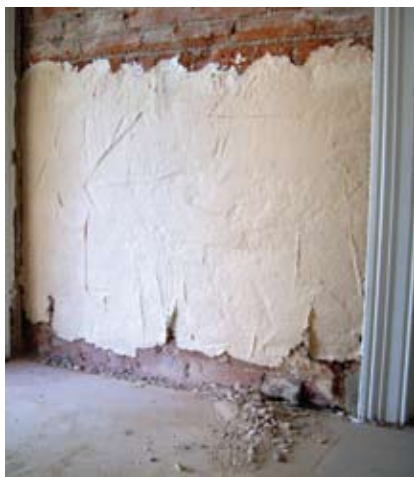
Figure 32 Absorbent poultice shortly after application to an interior wall from which plaster has been removed. The poultice is left on the wall until it is dry, which may take 2–3 weeks depending on weather conditions.

Poultices are applied wet to dryish masonry; the water contained in the poultice soaks slowly into the wall and dissolves salts, while the poultice shrinks onto the wall face (Figures 32 & 33). As the wall dries, water carrying salts in solution is drawn back to the surface by the high suction created by the fine pores in the poultice. The water evaporates and salts precipitate within the poultice, which is left on the wall until it dries out; this may take several weeks, depending on the weather. The poultice is then removed, taking the salt with it. Two or three cycles of poulticing may be required to reduce salt concentrations down to an acceptable level.

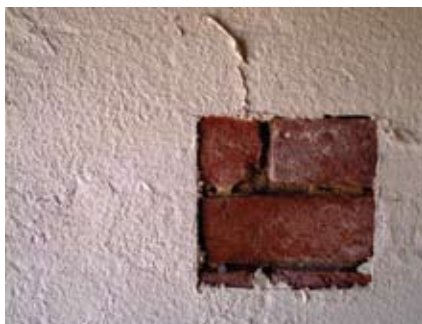
Figure 33 A square section of dried poultice has been cut out for chemical analysis. Sampling of the same point during subsequent cycles of poulticing is aided by a marker such as the galvanised nail in the bottom left of the 'window'.

As well as sampling the masonry for its salt content, poultice materials can be sampled as they are about to be removed from the wall (Figure 33). The results will not be comparable with those from the wall itself but can be used to monitor the effectiveness of poulticing over a series of cycles; later cycles will generally draw less salts, although experience suggests that sometimes the second cycle will draw more salt than the first. While a reduction in salt content will demonstrate the declining efficacy of further poulticing, it will not prove conclusively that the wall has been desalinated: only samples taken from the wall will do that. However, sampling the poultices has the advantage of not damaging the masonry: this may be important, particularly in high-value works such as sculpture.

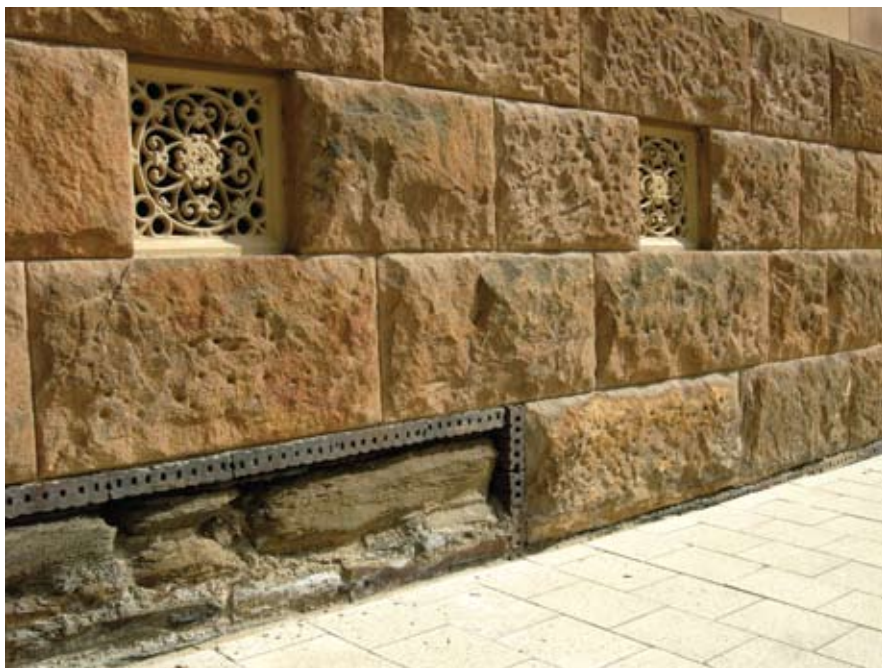
Figure 34 Stonework below the DPC needs attention as salts accumulate and the mortar and bluestone erode. In the first instance sacrificial treatments should be used to manage the problem. The 1879 ceramic DPC is doing an excellent job of protecting the sandstone above it, although where it steps down the slope it is compromised by hard paving that is laid too high, allowing splash onto the stone (see Box 2: *Location of DPCs*).

Responding to increasing salinity problems, some local councils are requiring higher standards of construction of modern buildings, particularly in regard to concrete slabs and footings for housing. This guide is about existing buildings and is focused on those that have deficient, absent or bridged damp-proof courses. Even buildings with good damp-proofing are not immune to salt damage and many will require ongoing maintenance to control the problem (Figure 34).

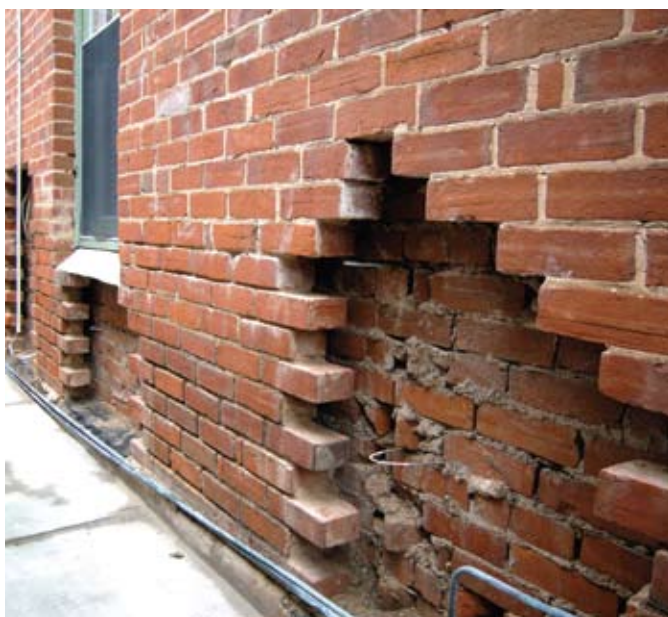
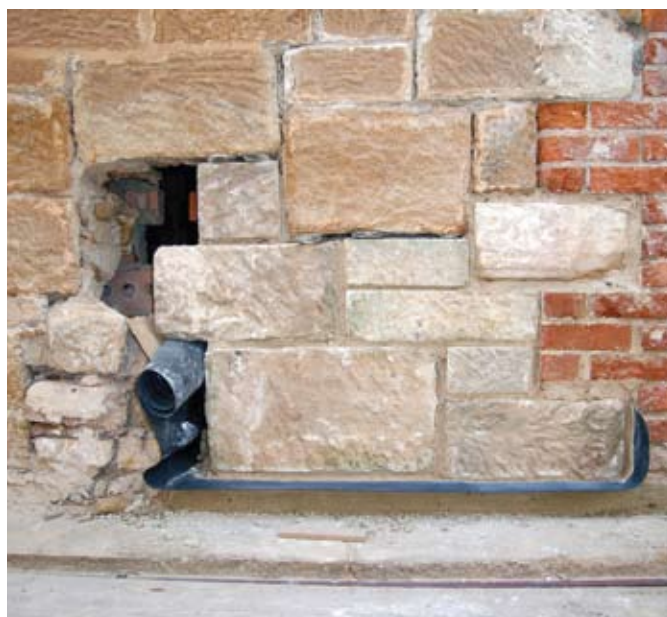
Figures 35 and 36 Undersetting to install new damp-proof courses. At left sections, known as pins, are removed from a cavity wall, while at right a pin has been rebuilt on a plastic DPC, the end of which is rolled up ready for use in the next section. In the case of cavity walls, such as at left, the inner leaf also needs to be treated, using one of the methods described in this guide. Where solid walls are being underset, such as on the right, the entire thickness of the wall must be removed and rebuilt to allow a DPC to be installed across the full width of the wall. Partial undersetting of a solid wall is bad practice as the damp will continue to rise through the remaining portion.

The traditional physical means of introducing a new DPC is the technique known as undersetting, or masonry replacement. Undersetting should not be confused with underpinning, which is a treatment for structural cracking due to settlement or footing failure. In undersetting, sections of the base of the wall are removed down to the footing and progressively replaced with new materials and a DPC. Small sections (or pins) of brick or stonework are removed (including all decayed material), leaving pillars to support the wall structure (Figure 35). A DPC is incorporated as each pin is rebuilt; after the new mortar cures the top joint is packed tightly to take up the load of the wall (Figure 36). Adjacent sections are then removed and rebuilt until the whole wall has a new base incorporating a continuous DPC. Figure 37 is an example of undersetting carried out in the 1930s.

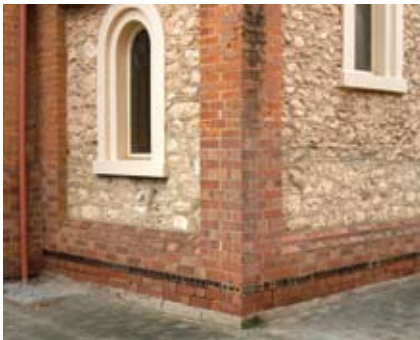
Figure 37 Undersetting from the 1930s. New bricks and stones have been inserted up to a line above the window sill on the left. Bricks below the DPC are visibly damp (see also Figure 10).

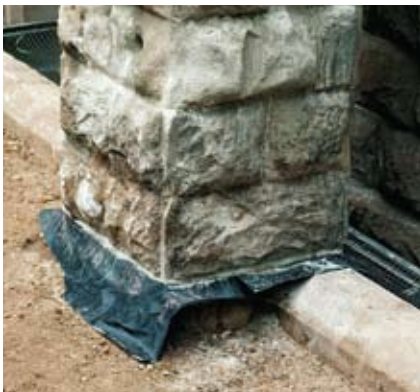
Figure 38 Insertion of a DPC by slot sawing. A mortar joint is sawn out with a chainsaw allowing insertion of DPC sheeting. As salt-laden stone is left above the DPC, the technique must be combined with desalination to be successful.

DPC sheeting is inserted into the saw-cut, which is then packed with stiff mortar and tightly rammed to take up the load of the walls (Figure 38). After the mortar cures the next section of joint can be sawn out and work progresses around the walls. A potential problem with this method is the perforation of plastic DPCs owing to the (correct) use of sharp sands and the ramming necessary to pack the joint tightly. Thicker (0.75 mm) DPC material is recommended in these cases.

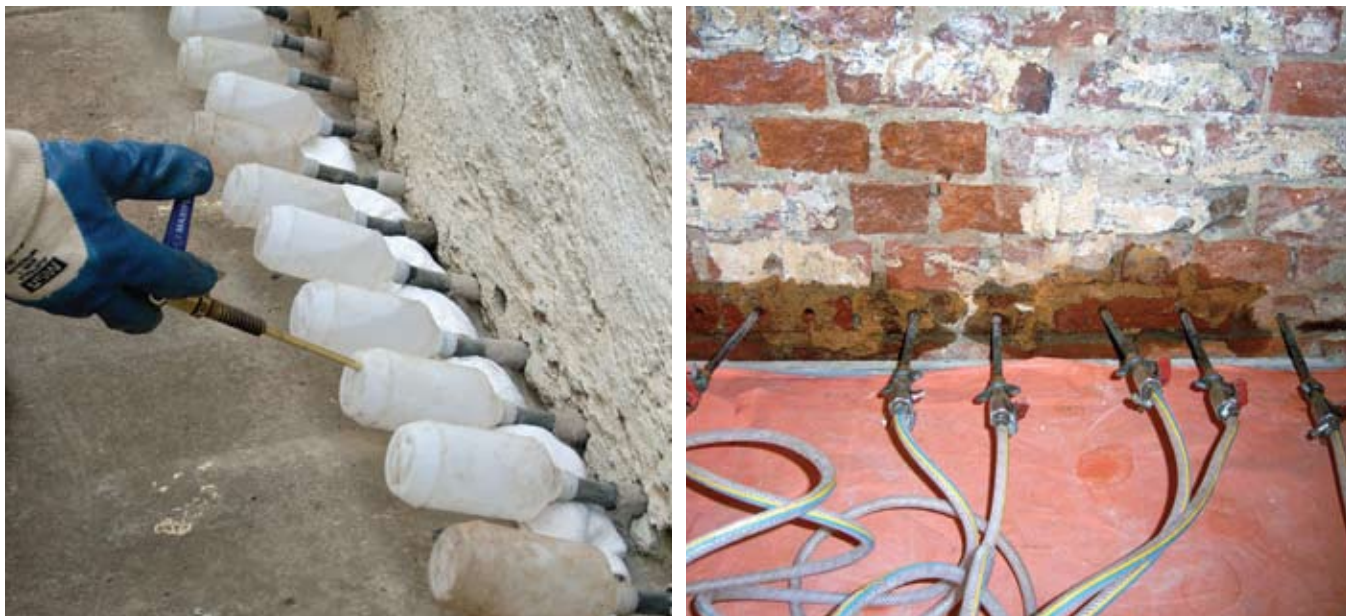
Figure 41 and 42 Chemical impregnation. On the left: the gravity-fed system in which small plastic bottles are filled with a lance. Depending on the nature of the masonry and thickness of the wall the bottles are filled three and sometimes four times. Open holes just above the drilled line are used to indicate extent of penetration. On the right: low-pressure injection in progress on an interior wall from which plaster has been removed. Note the variation in the permeability of the brickwork; the brick on the left is already saturated and the lance is moved on while the central brick slowly fills with fluid.

Fluid is delivered into the holes by either a tube or a lance depending on whether it is to be gravity-fed or injected under low pressure (Figures 41 & 42). The choice of technique is to some extent determined by the nature of the masonry: gravity-fed diffusion is suitable for porous mortars and soft bricks, while normal bricks can be injected under low pressure (20–70 psi, 150–500 kPa). High pressure injection (greater than 150 psi, 1000 kPa) risks the blowout of weak mortars and imperfect coverage in sound materials due to viscous fingering, a process in which the fluid advances as a series of fingers, leaving gaps between.

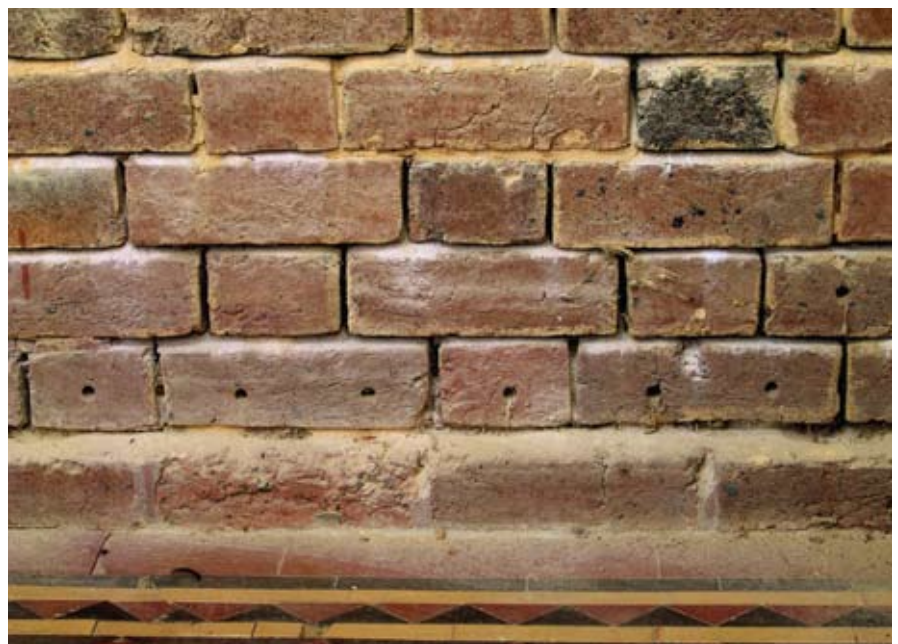
Figure 43 Despite chemical impregnation, decay continues to the brickwork above the treated zone. This is because salts remain in the wall and can cycle in and out of solution with changes in humidity, causing ongoing salt attack decay. The yellow sand is what remains of a sacrificial mortar applied at the time of chemical impregnation. The white material is a mixture of the original lime mortar and salt. Further treatment should include raking out the salty mortar and repointing in a sacrificial mix and possibly poultice desalination, together with an assessment of the effectiveness of the chemical DPC. Note that extensive repointing may bridge the DPC, and so it may need re-treatment once the new mortar is well-cured. Alkaline-stable damp-course fluids should be used.

► See Sections 6, 13, 14 and 16.3 and also Figure 43.

Importantly, chemical impregnation provides only a barrier to rising damp; it does not prevent salts in the walls above the new damp-proof zone from cycling in and out of solution with changes in humidity, and so continuing to cause damage. **Chemical impregnation must be combined with sacrificial treatments and/or desalination for it to be a successful treatment for salt damp** (Figure 43).

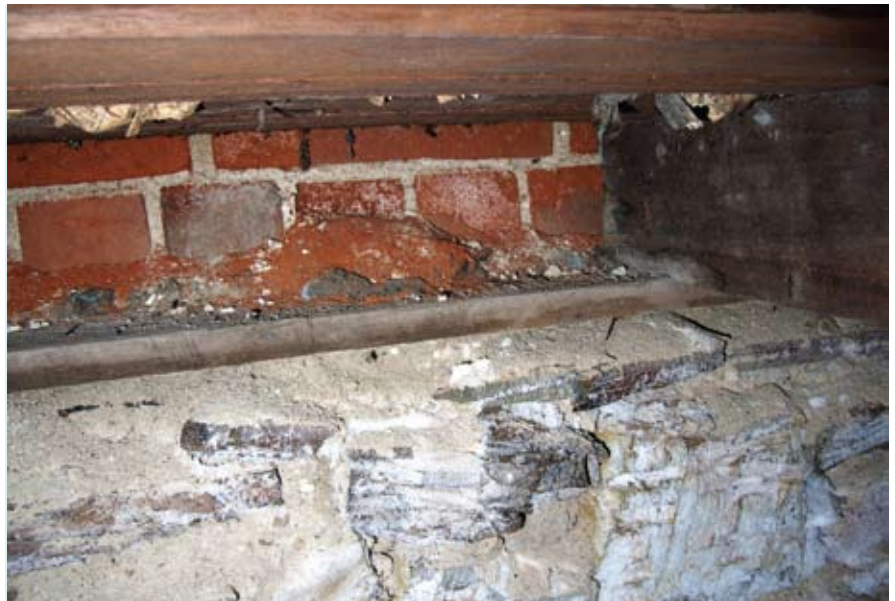
Figure 50 Looking beneath a floor at the edge of a debris-covered floor plate. There are water stains on the end and base of the joist. Salt attack is damaging the bricks at the rear, which are slowly crumbling onto the floor plate. Dense salt crystals encrust the surface of the rubble bluestone in the foreground. The lack of a membrane beneath the floor plate means that the floor timbers are at greater risk of fungal rot and termite attack.

Whichever treatment is used, it may be desirable to apply a sacrificial plaster to the face of the wall below the new membrane. More thorough desalination will be required for very salty walls, such as that shown in Figure 50.

Figure 50 shows a similar view beneath the floor of another house. Salt attack is decaying the brickwork and the debris is accumulating on the damp floor plate. The brick debris overlies previous plaster material which has fallen onto and behind the plate, thereby making a bridge across the DPC which is located out of sight, directly behind the floor plate. Unfortunately the plate is not isolated from the damp masonry below, a situation that is common in Australian buildings. Note the extensive salt efflorescence on the face of the bluestone rubble.

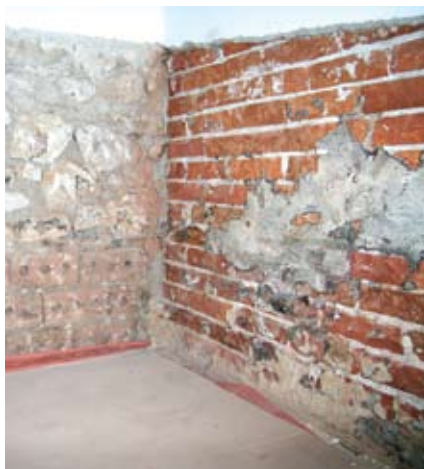
Figure 51 Discoveries on removing plaster from interior walls. On the left, the brick-on-edge is a partial undersetting of the inner part of a solid wall, leaving the outer part untreated — a total waste of effort. On both walls, but more apparent on the right, are remnants of a dense hard cementitious material containing milled iron that was designed to rust and block pores, making it impermeable. Its removal proved extremely difficult.

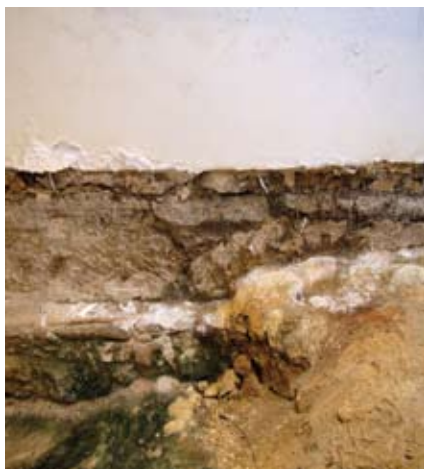
Figure 53 Damaged plaster on a damp wall; the dampness is indicated by green algae and white salts crystallising on the stonework and fill below. The recent plaster is decaying because it contains gypsum.

This is because gypsum, which is calcium sulphate ($\text{CaSO}_4 \cdot 2\text{H}_2\text{O}$) is a slightly soluble salt and any moisture will trigger salt attack within the new plaster (Figure 53). Use only lime or lime-cement plasters where walls may be subject to continuing dampness. Portland cements contain gypsum and other salts which may add to a damp problem. Specify low-alkali cements to keep salts to a minimum.

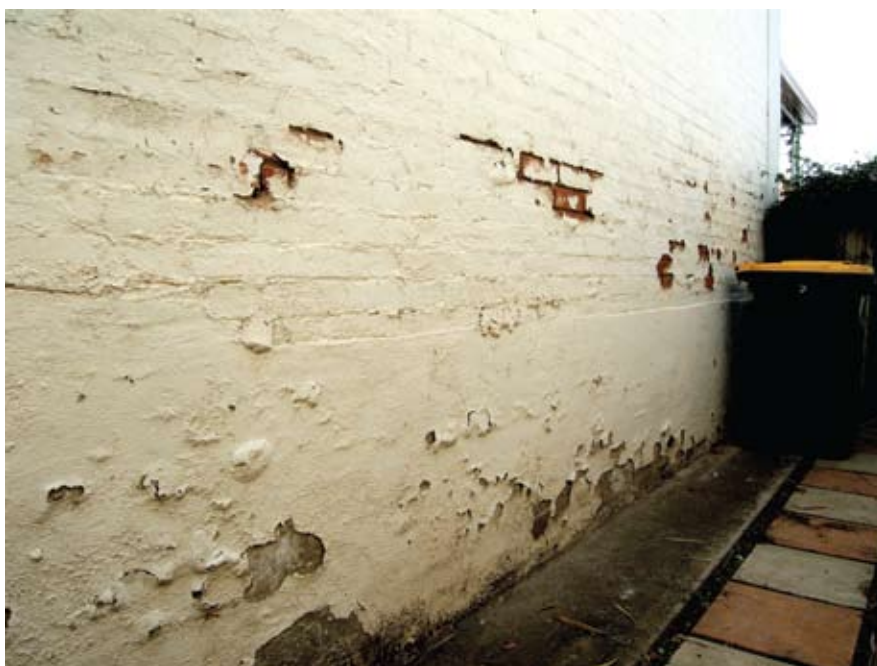
Figure 54 Failure of an acrylic paint coating due to salt damp. The bottom part of the wall is rendered in cement, which has contributed to the damp rising further due to its relative (but not total) impermeability. Decay of the brickwork is focussed where the paint film fails because that's where salt crystallises as moisture evaporates. The paint and the render should be removed and replaced with a more vapour-permeable coating such as limewash.

The same principle can be applied to plasters or renders. By using weak plasters the evaporative front (and hence decay) is moved from the original masonry out into the new plaster. Provided there is sufficient evaporation from the sacrificial plaster, decay can be limited to the lower parts of a wall. These treatments are the opposite of the incorrect practice of rendering the base of affected walls with dense, relatively impermeable cement renders. This simply prevents the evaporation of moisture, which continues rising up the wall until it can evaporate above the render, starting the problem all over again (Front cover & Figure 54).

Acrylic (water-based) paints are more vapour-permeable than alkyd (oil-based) paints; the latter should not be used where walls remain damp or are still drying out after DPC insertion. Even the acrylics can be too impermeable for old walls (Figure 54). In these circumstances alternative coatings such as cement-based paints and traditional limewashes should be considered. Limewashes are more vapour-permeable than cement-based paints.

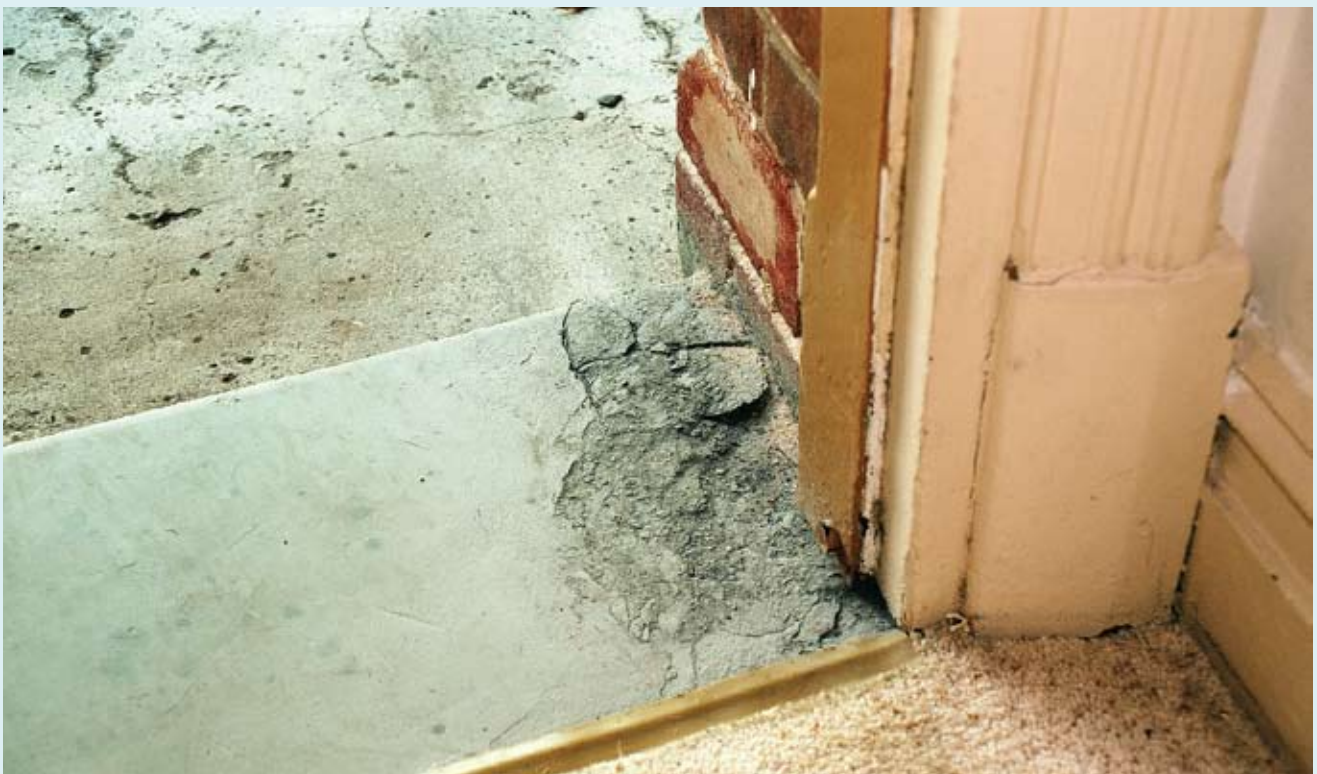
Box 9, Figure 55

A brick house built in about 1900 had a slate front doorstep. Mild damp affects parts of the house particularly near the front door, causing the doorstep to delaminate and become powdery on the surface due to salt attack. The badly worn step was replaced in the mid-1980s with a new piece of slate from the same quarry. Within five years the new step began to decay in the same manner (Figure 55, below). What happened? Why did the first step last eighty-odd years and yet the second need replacing after ten? Perhaps the slate is not what it used to be?

The dense layered nature of slate contributes to its demise — its very fine pore structure has a high suction along the layers, while being relatively impermeable across the layers. Thus the slate will draw any available moisture in from its edges — edges which are butted against salty brickwork.

The third step, which is now doing fine after ten years, had its edges sealed with slate sealer prior to installation (several coats of siloxane dampcourse fluid would be an alternative). The new step is bedded on a plastic DPC and on weak mortar that will decay sacrificially in preference to the adjacent brickwork.
